Memorandum

Re: Westpoint Harbor Wetland Vegetation Mitigation Monitoring

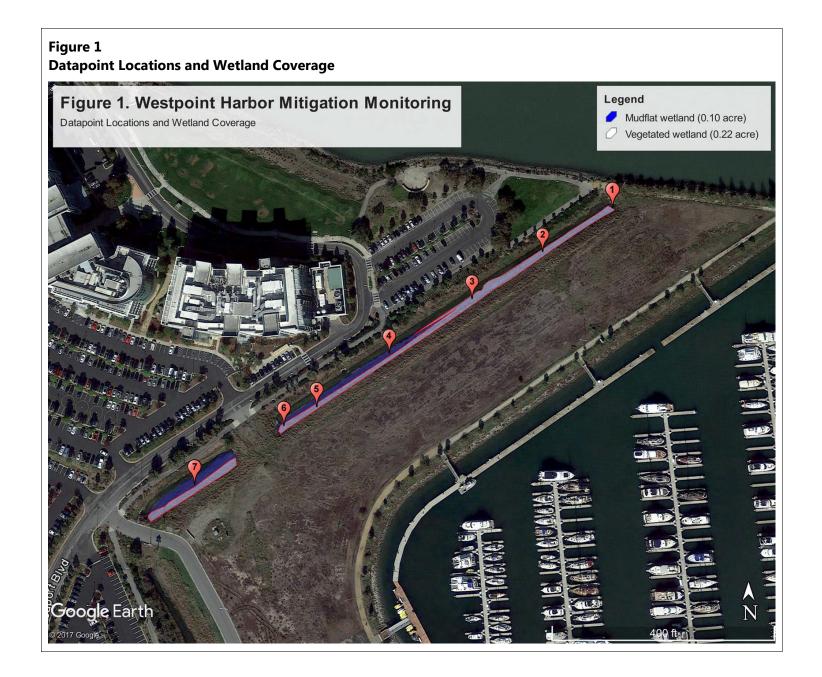
Seven datapoints were recorded from east to west from the easternmost culvert to the San Francisco Bay (Figure 1; Attachment 1 Photographs 3 through 9). Vegetation was assessed to determine the dominance of wetland vegetation according to methods from USACE's September 2008 *Interim Regional Supplement to the Corps of Engineers Wetland Delineation Manual: Arid West Region.* Plant species observed consisted of a combination of native and non-native species. Plants typical of salt marsh within the San Francisco Bay shoreline were observed, including pickleweed (*Salicornia pacifica*, obligate [OBL]), alkali heath (*Frankenia salina*, facultative wetland [FACW]), marsh jaumea (*Jaumea carnosa*, OBL), Mediterranean barley (*Hordeum murinum* var. *gussoneanum*, facultative [FAC]) and sickle grass (*Parapholis strigose*, OBL), which were found below the mean high tide line (MHT). Above MHT, the slope supported non-native grasses, with tall wheat grass (*Elymus ponticus*, UPL) as the dominant species. Italian rye (*Festuca perennis*, FAC) and rip-gut brome (*Bromus diandrus*, UPL) also occurred in much lower numbers. Specific findings for the seven datapoints shown on Figure 1 are presented in the following tables. Note that, due to the potential for vegetation overlap, the cumulative percent coverage may exceed 100%.

As noted above, the dominant wetland indicator species throughout the project site was pickleweed. The aerial signature of pickleweed (indicative of vegetated tidal marsh wetland) appears red on aerials and was used to draw polygons on the map representative of salt marsh vegetation coverage within the restoration area, as shown on Figure 2. Non-vegetated mudflat wetlands were also observed at Datapoint 4, and adjacent to Datapoint 7. These areas were also visible on aerials, and are also shown on Figure 1.

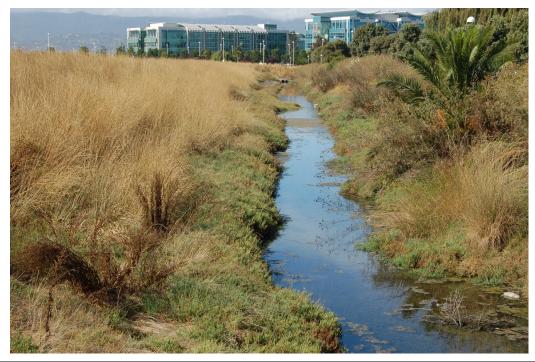
At Datapoints 1, 2, 3, 5, and 6, percent cover exceeded 100%; this corresponds to a total area of 0.21 acre with 100% or higher coverage (see typical conditions in Attachment 1, Photograph 1). Datapoint 7 contained the sparsest coverage at 77%, over an area of approximately 0.01 acre (see Attachment 1, Photograph 9). Non-vegetated mudflat wetlands occur over an area of 0.10 acre on the southeast bank of the channel (see typical conditions in Attachment 1, Photograph 2). This corresponds to a total wetland area of 0.32 acre (including 0.22 acre of 100+% vegetated salt marsh; 0.01 acre of 77% vegetated salt marsh; and 0.10 acre of unvegetated mudflat) within the restoration area (the southeast bank of the channel).

Hydrologic conditions were evaluated based on observed site conditions. An MHT line was clearly visible within the channel (see Attachment 1, Photographs 1 and 2), and connectivity to the San Francisco Bay to the east was observed (see Figure 1). At the time of the site visit, the channel depth was several inches. Soils beneath MHT are presumed hydric based on this observed hydrology regime.

Photograph 1 View of Typical 100+% Wetland Vegetation Coverage Area in Channel

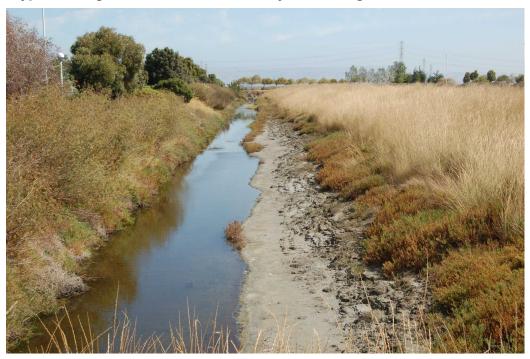
Photograph 2 View of Typical Unvegetated Mudflat Wetland adjacent to Vegetated Wetland within Channel

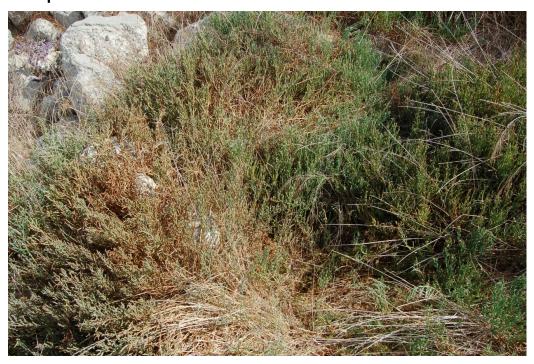
Datapoint 1

Species	Indicator Status	Percent Cover
Salicornia pacifica	OBL	80
Frankenia salina	FACW	15
Festuca perennis	FAC	5
Hordeum murinum var. gussoneanum	FAC	5
Bromus diandrus	UPL	5
	Total Cover	110

Photograph 3 View of Datapoint 1

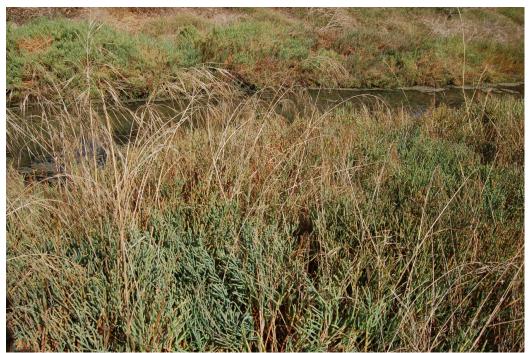
Datapoint 2

Species	Indicator Status	Percent Cover
Salicornia pacifica	OBL	100
Bromus diandrus	UPL	5
	Total Cover	105

Photograph 4
View of Datapoint 2

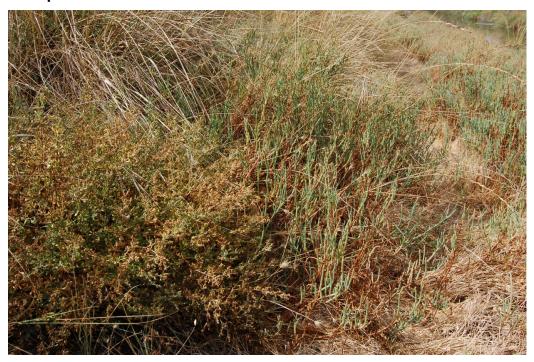
Datapoint 3

Species	Indicator Status	Percent Cover
Salicornia pacifica	UPL	40
Frankenia salina	FACW	30
Parapholis incurva	OBL	20
Hordeum murinum var. gussoneanum	FAC	8
Elymus ponticus	UPL	2
	Total Cover	100

Photograph 5 View of Datapoint 3

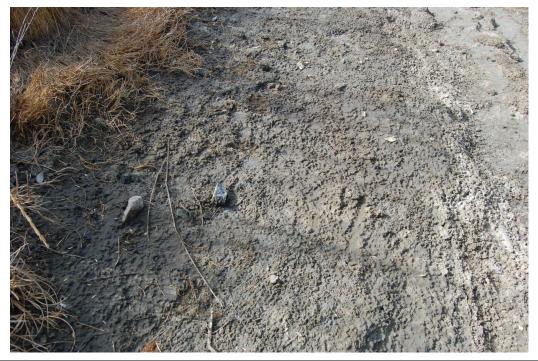
Datapoint 4

Bare ground. Vegetation up slope from this location supports *Parapholis incurva* and *Elymus ponticus*. Down slope, toward the water's edge, vegetation consists of *Salicornia pacifica* and *Jaumea carnosa*.

Photograph 6 View of Datapoint 4

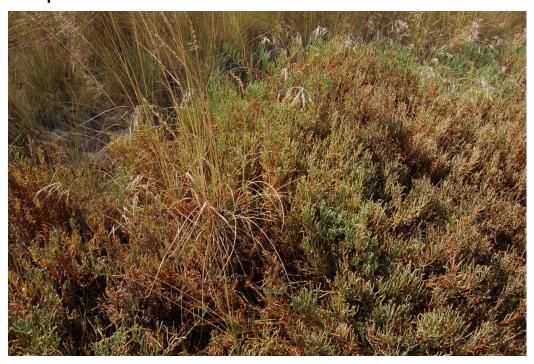
Datapoint 5

Species	Indicator Status	Percent Cover
Salicornia pacifica	OBL	100
Elymus ponticus	UPL	5
Bromus diandrus	UPL	2
	Total Cover	107

Photograph 7 View of Datapoint 5

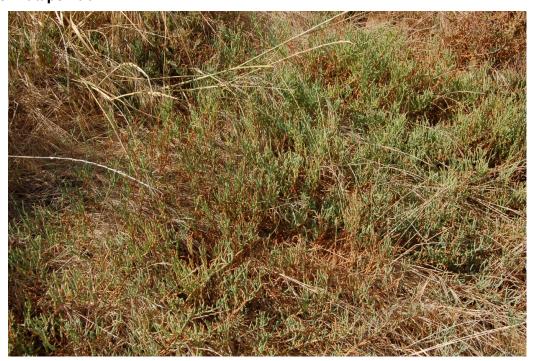
Datapoint 6

Species	Indicator Status	Percent Cover
Salicornia pacifica	OBL	100
Parapholis incurva	OBL	6
Elymus ponticus	UPL	3
	Total Cover	109

Photograph 8
View of Datapoint 6

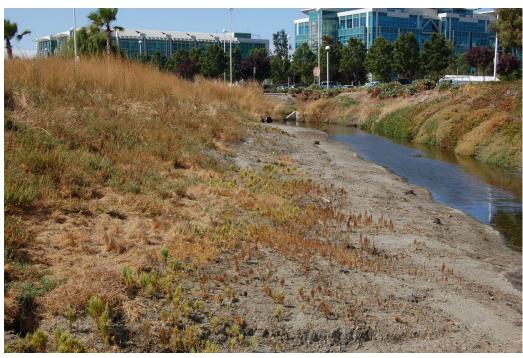
Datapoint 7

Species	Indicator Status	Percent Cover
Salicornia pacifica	OBL	40
Parapholis incurva	OBL	25
Elymus ponticus	UPL	5
Bromus diandrus	UPL	5
Festuca perennis	FAC	2
	Total Cover	77

Photograph 9 View of Datapoint 7
